# **Mold/Water Damage Investigation**

**Old Rochester Regional High School  
TV Studio  
135 Marion Road  
Mattapoisett, Massachusetts**

Prepared by:  
Massachusetts Department of Public Health  
Bureau of Environmental Health  
Indoor Air Quality Program  
September 2007

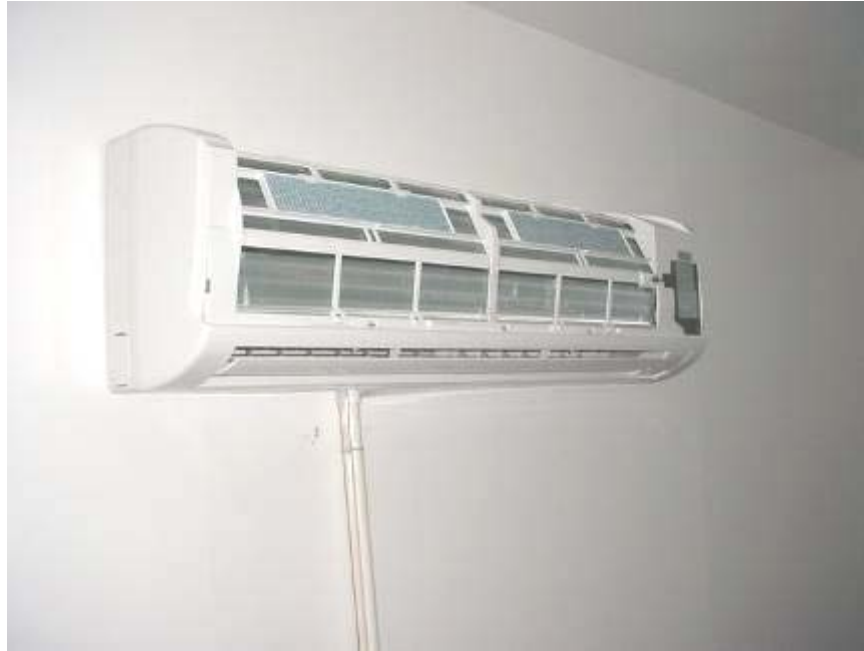
**Picture 1**

As previously mentioned the assessment was prompted by concerns of mold growth in the TV studio. Mr. Shiraka reported that the source of moisture was suspected of being related to a wall-mounted air conditioning (AC) unit that had been retro-fitted into the control room (Picture 1). Condensation generated by the AC is drained by a clear plastic tube and pumped vertically above the ceiling system through an adjacent mechanical room and discharged via a drainage pipe that extends out the exterior wall (Pictures 2-5).

**Wall-Mounted AC Unit Retro-fitted in TV Studio Control Room, Note Drainage Tube (Bottom)**

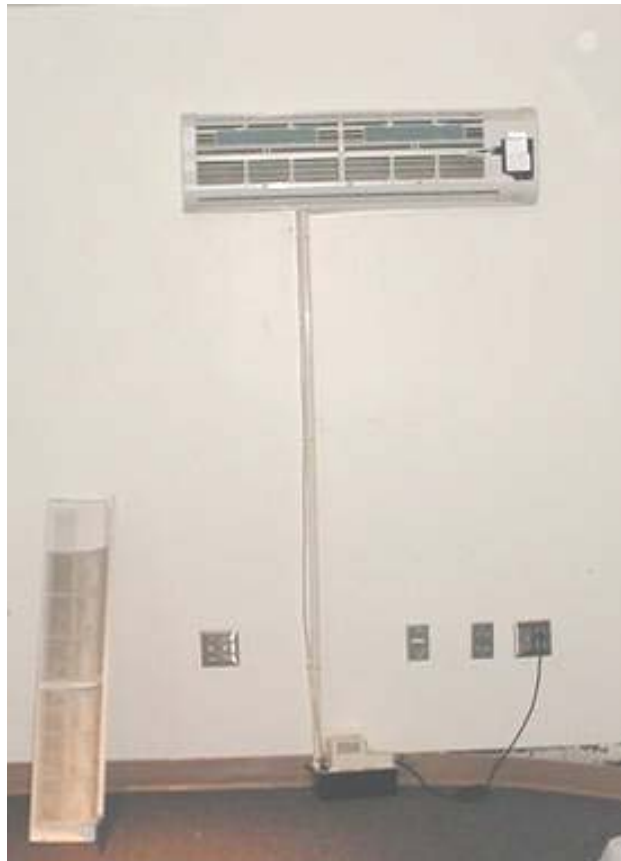
**Picture 2**

**Wall-Mounted AC Unit Retro-fitted in TV Studio Control Room, Note Drainage Tube and Mechanical Pump on Floor**

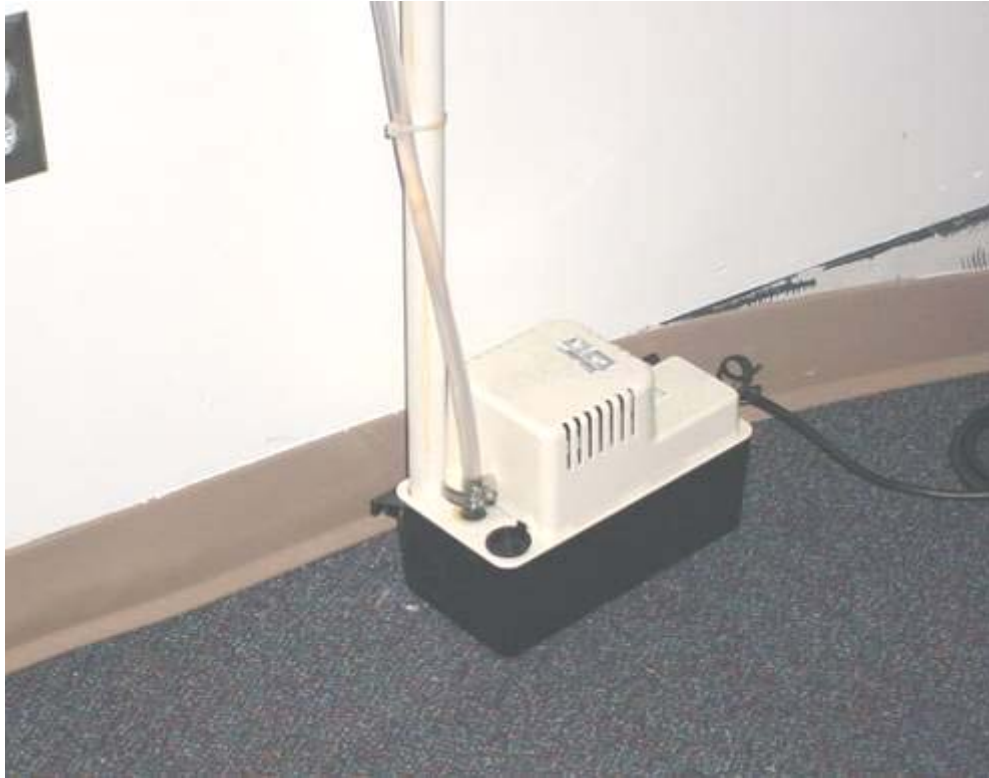
**Picture 3**

**Close up of AC Condensation Drainage Pump**

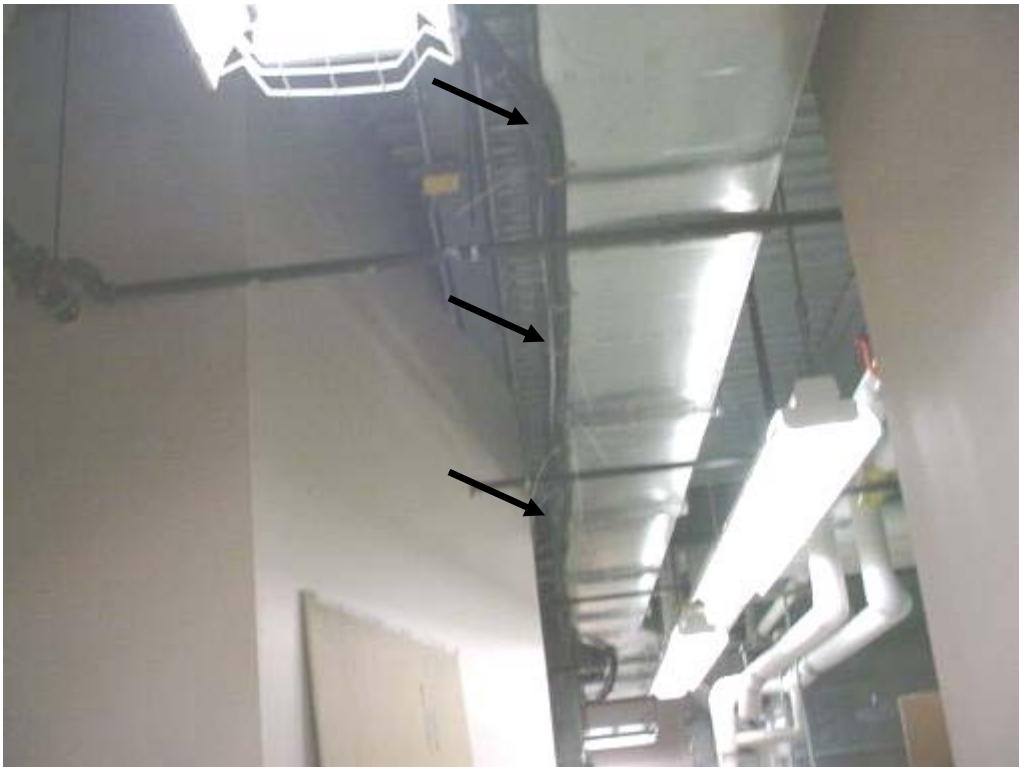
**Picture 4**

**AC Condensation Drainage Hose (Parallel to Ductwork) along Ceiling of Mechanical Room**

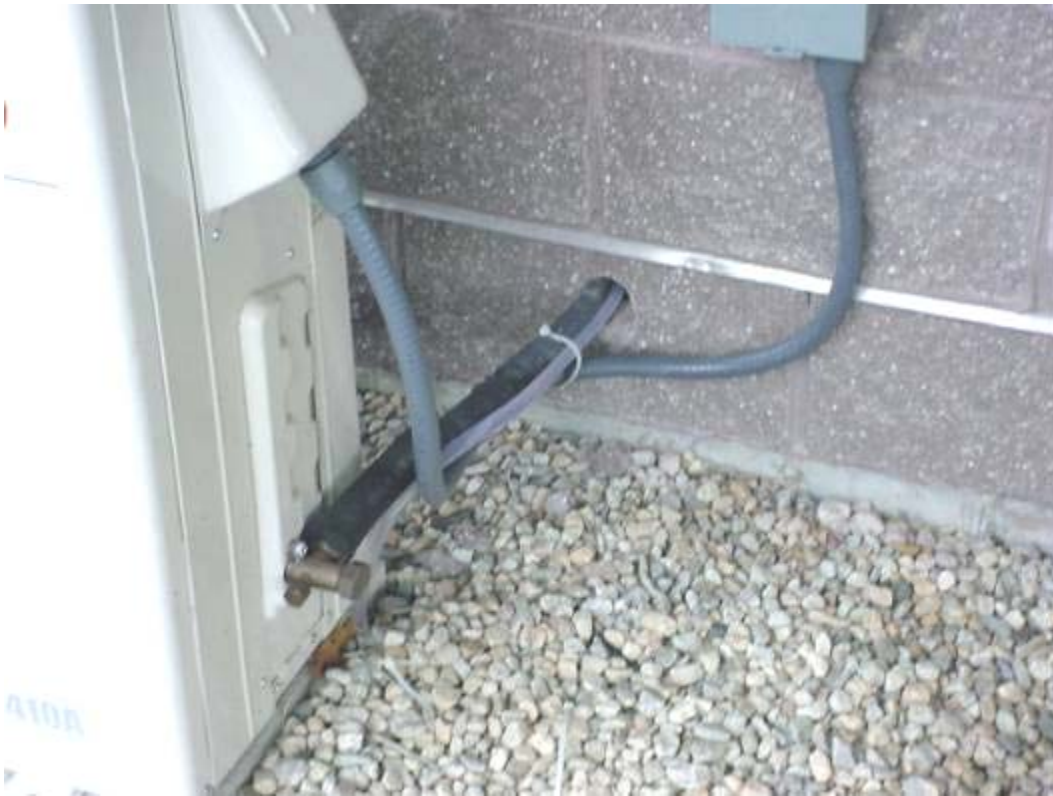
**Picture 5**

**Terminus of AC Condensation Drainage Hose (Exterior of the Building)**

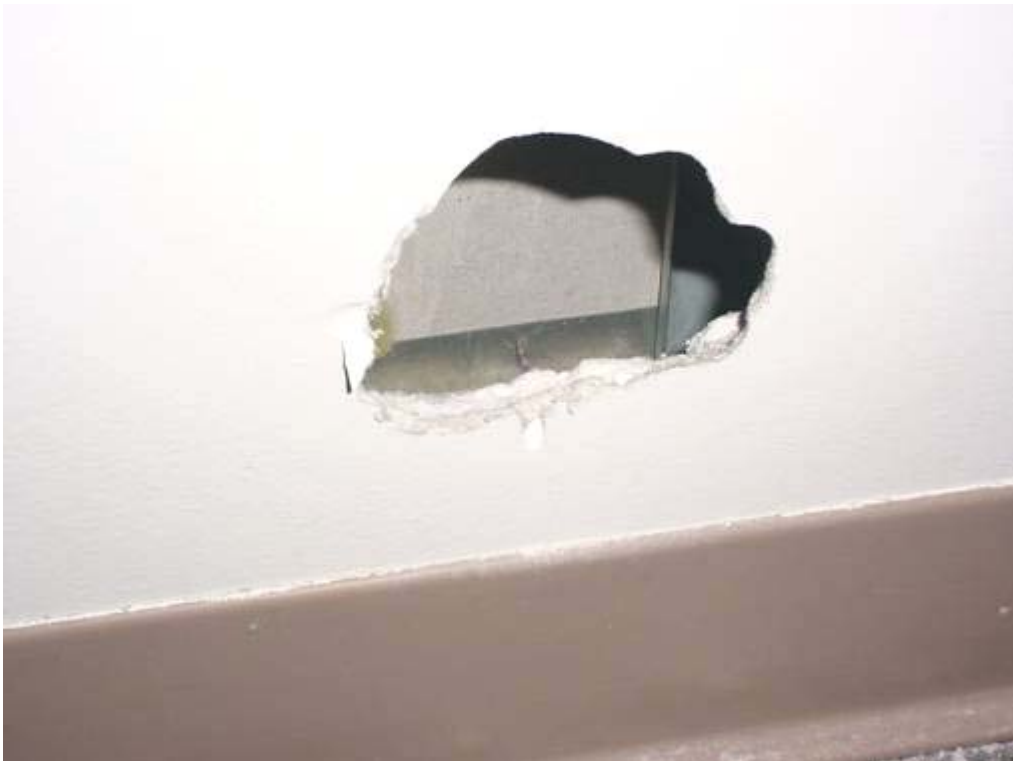
**Picture 6**

Prior to the BEH assessment, carpeting and sections of gypsum wallboard (GW) and vinyl base coving were removed in several areas to investigate potential sources of mold growth (Pictures 6-11). BEH staff examined building materials in the TV studio suite and found no water damage or visible mold growth.

**Section of GW Removed to Inspect Wall Cavity**

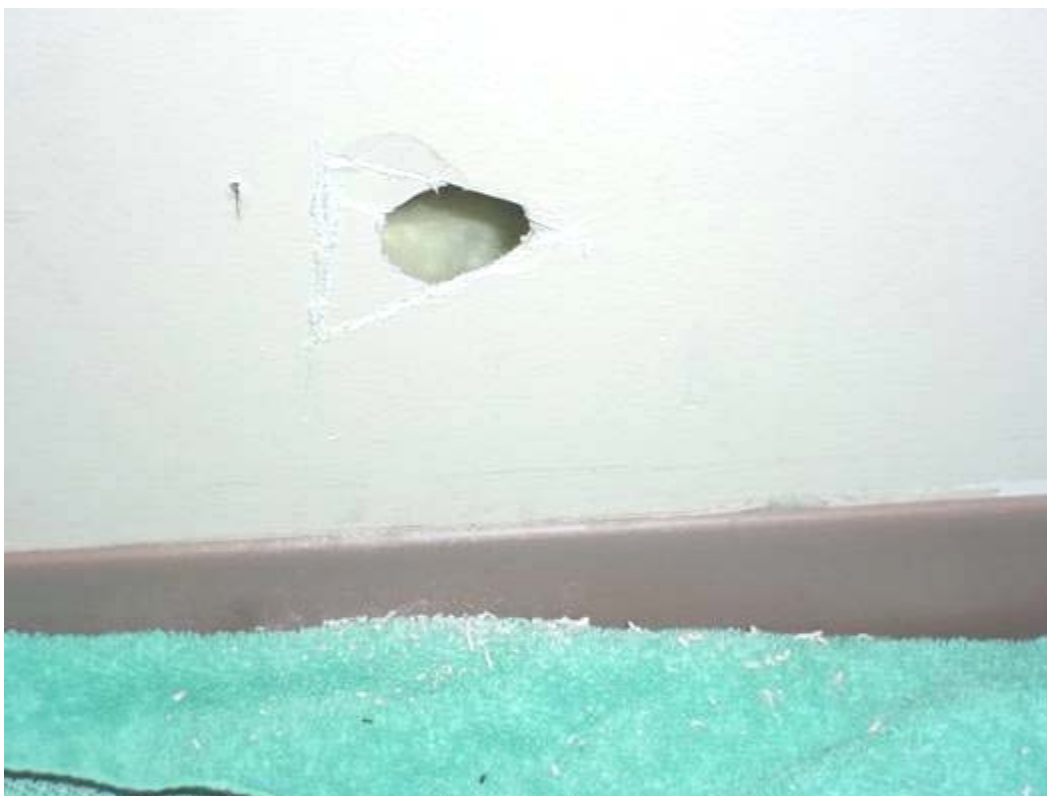
**Picture 7**

**Section of GW Removed to Inspect Wall Cavity**

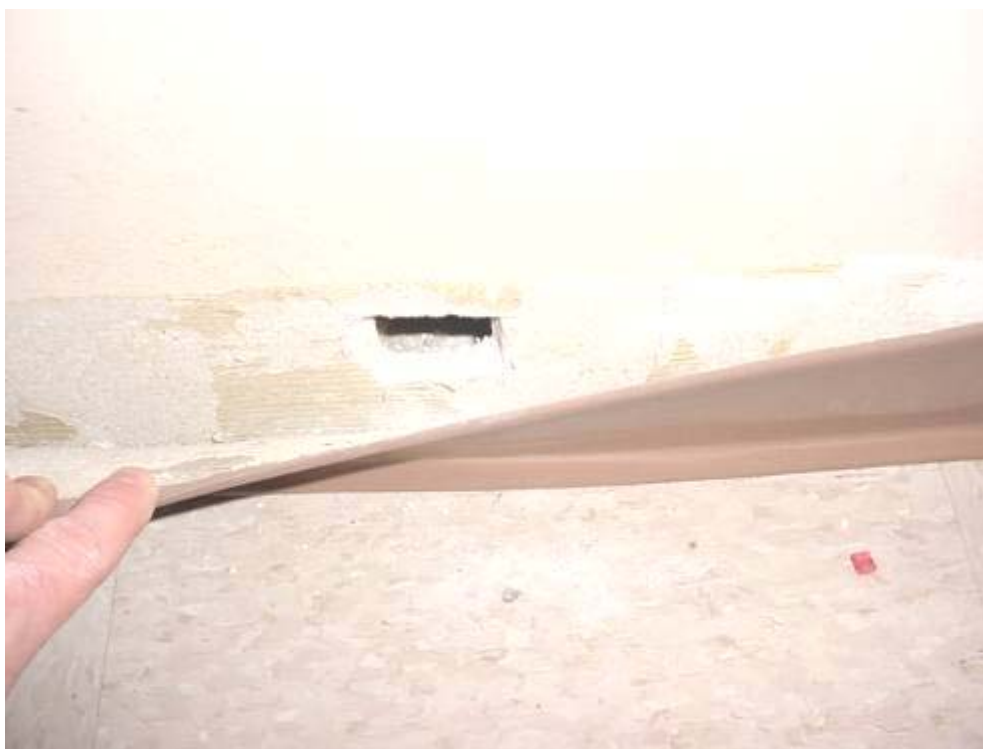
**Picture 8**

**Section of GW Removed to Inspect Wall Cavity behind Vinyl Coving**

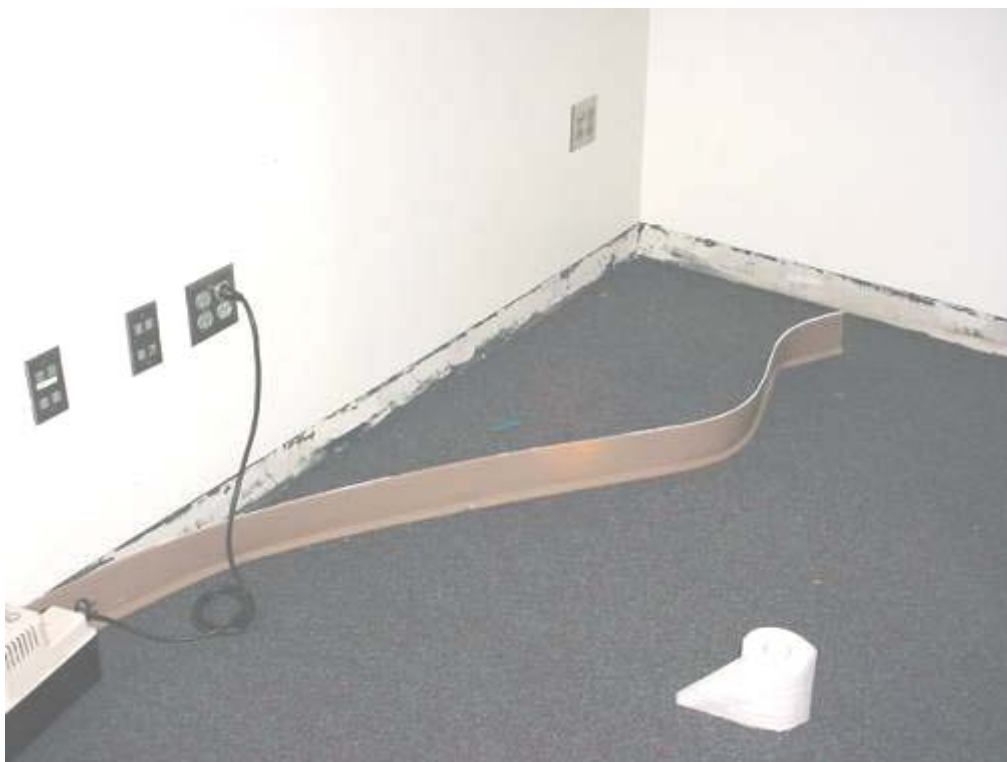
**Picture 9**

**Vinyl Base Coving Removed to Examine for Mold Growth**

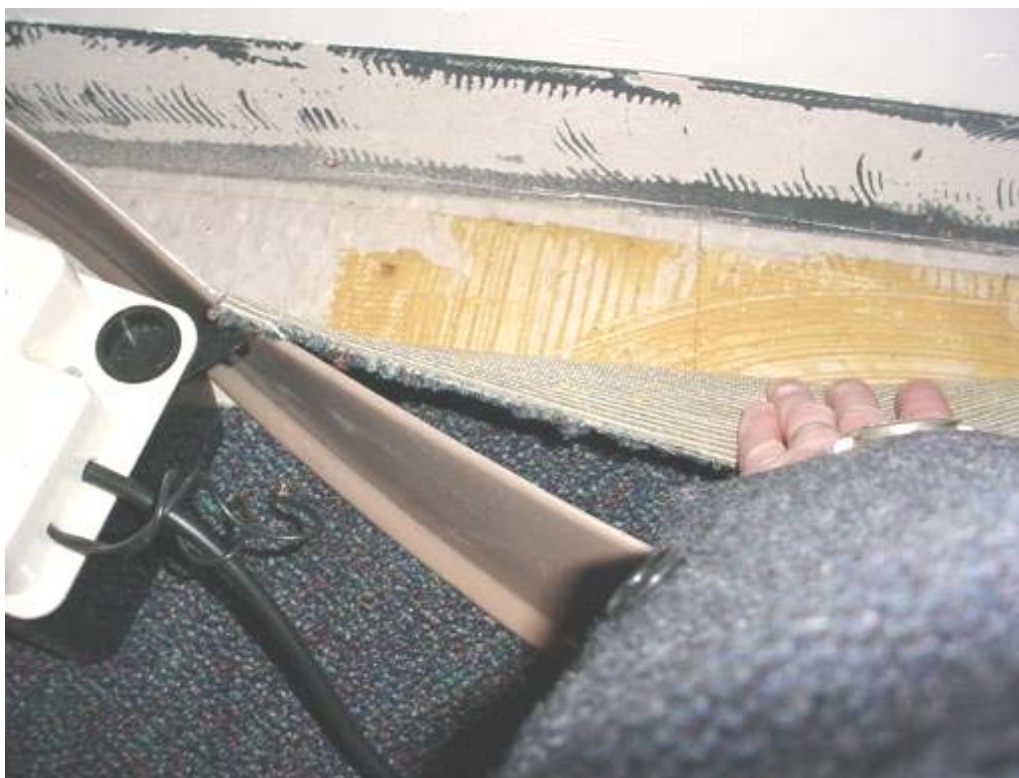
**Picture 10**

**Carpeting and Vinyl Base Coving Removed to Examine for Mold Growth**

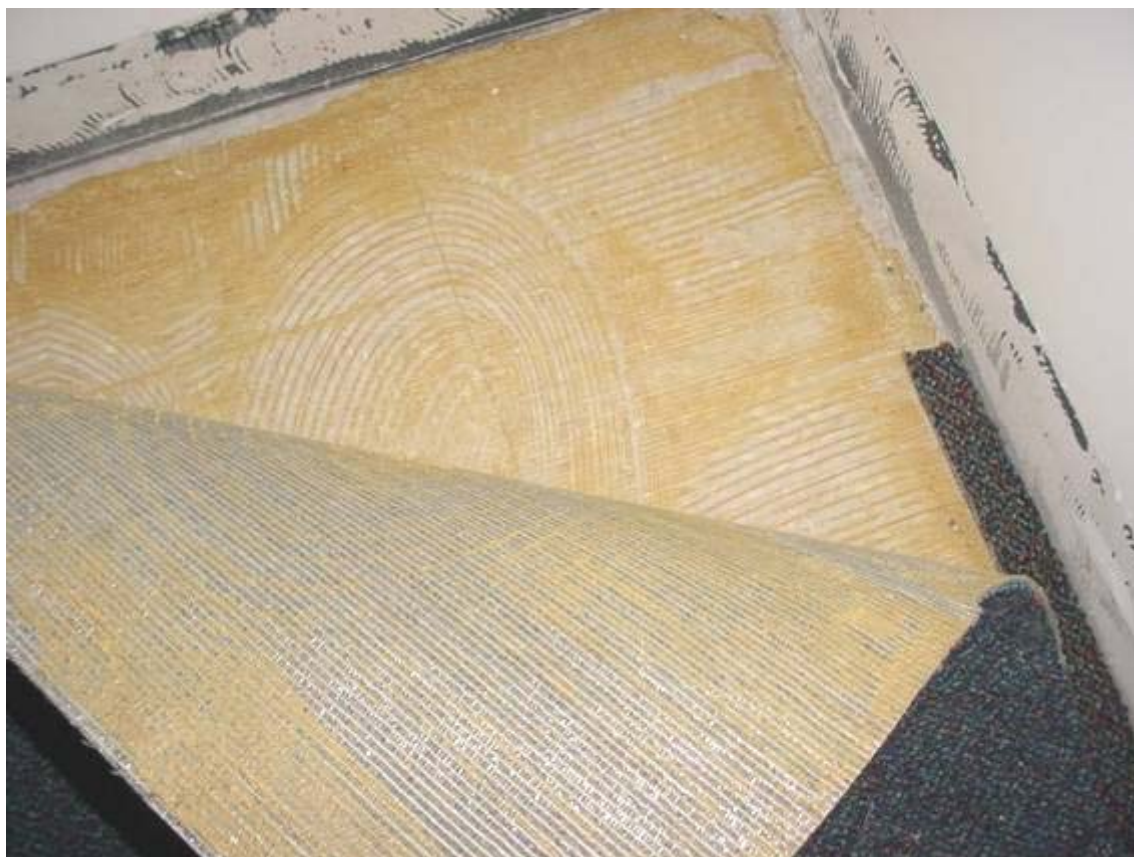
**Picture 11**

**Carpeting and Vinyl Base Coving Removed to Examine for Mold Growth**
